RigScan Report

AVO05A244 (Boomer 282)

For EBC inc

RigScan Final Report

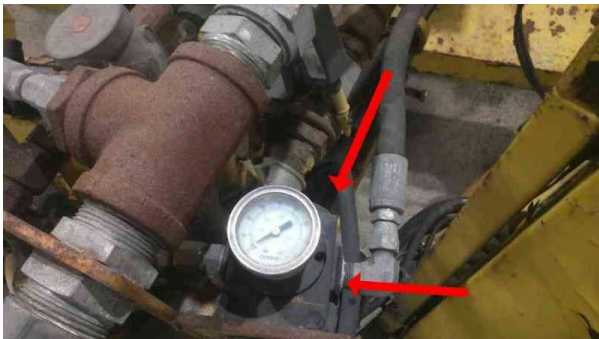
FAIL
Step Title: Check ECL Regulator Condition **Results:** YES
Resolution Diagnosis: To be replace,dry diaphragms
Resolution Action: Replace
Resolution Priority: Critical Safety
Resolution Benefit: Machine Safety
Zone: Left Front and Front of Carrier
Subsystem: Drilling system 1
Subequipment: Lubrication ECL 1

To be replace,dry diaphragms

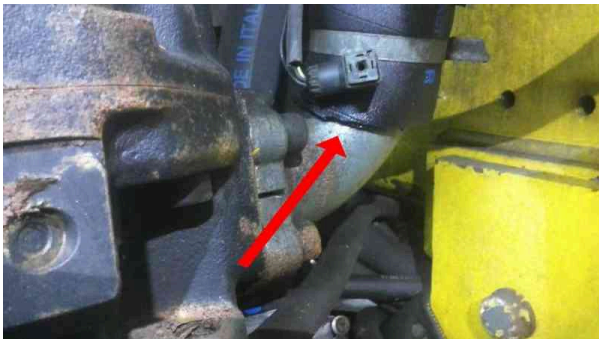
FAIL
Step Title: Check Pumps Condition
Resolution Diagnosis: Leaks on the suction hoses, already on order
Resolution Action: Repair
Resolution Priority: Critical Safety
Resolution Benefit: Machine Safety
Zone: Right Rear of Carrier
Subsystem: Hydraulic System 1
Subequipment: Hyd. Pump

suction hoses are leaking

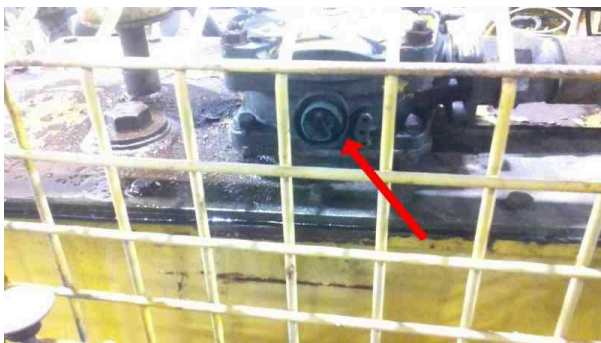
Resolution Diagnosis: Gauge is broken on the filters casing, oil level sensor and gauge for the temp. is not working need to be bypass

Filters gauge broken, need to be replaced

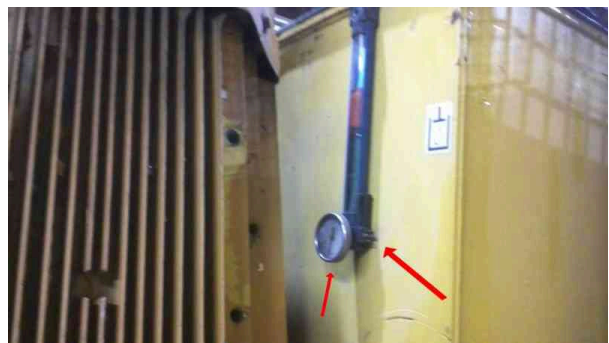
Oil level sensor not working and temperature gauge also

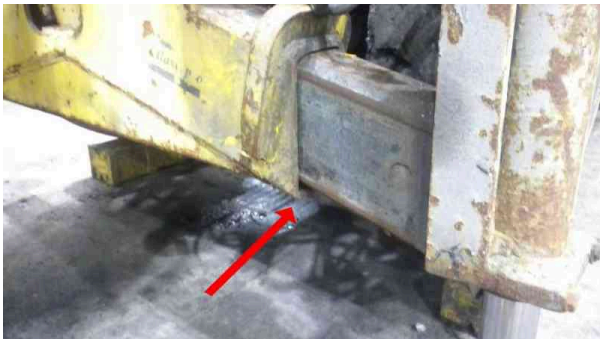
FAIL
Step Title: Check Leveling Cylinder Condition
Resolution Diagnosis: Outrigger need to be rebuilt,loose
Resolution Action: Repair
Resolution Priority: Critical Safety
Resolution Benefit: Machine Safety
Zone: Left Front and Front of Carrier
Subsystem: Hydraulic System Common
Subequipment: Jacks

Outrigger need to be rebuilt,loose

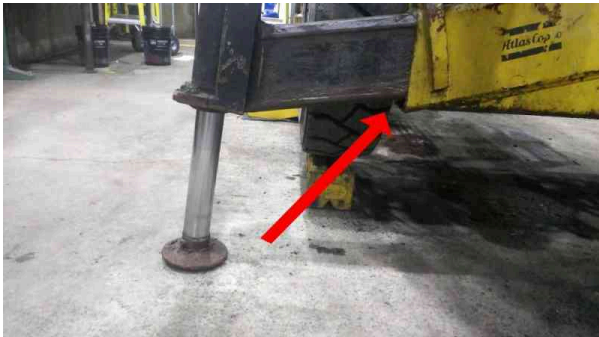
FAIL
Step Title: Check Leveling Cylinder Condition
Resolution Diagnosis: Right outrigger loose,tefflons have to be replace,parts already order for the other side
Resolution Action: Replace
Resolution Priority: Critical Safety
Resolution Benefit: Machine Safety
Zone: Right Front of Carrier
Subsystem: Hydraulic System Common
Subequipment: Jacks

Right outrigger loose,tefflons haves to be replace

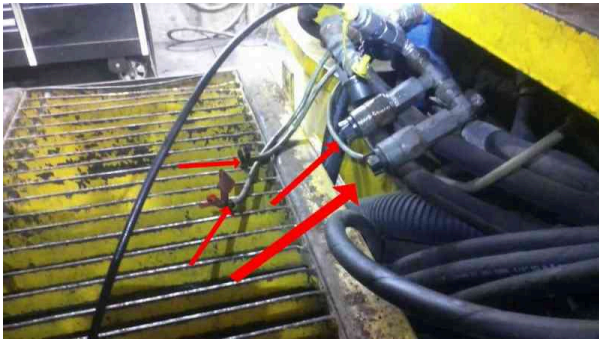
FAIL
Step Title: Check Low Brake Pressure Warning
Resolution Diagnosis: Sensors broken, need to be replace
Resolution Action: Replace
Resolution Priority: Critical Safety
Resolution Benefit: Machine Safety
Zone: Cabin/Canopy
Subsystem: Hydraulic System Common
Subequipment: Brake & Steering

Brake sensors broken, need to be replace

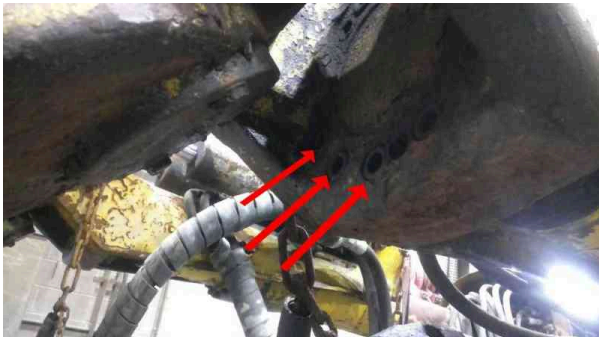
Issue Number: 22
Status:   FAIL
Step Title: Check Boom Extension Condition
Resolution Diagnosis: Bolts loose on the boom extension cylinder
Resolution Action: Repair
Resolution Priority: Critical Safety
Resolution Benefit: Machine Safety
Zone: Left Boom
Subsystem: Positioning System 1
Subequipment: Boom 1 Telescope

Bolts on boom extension cylinder

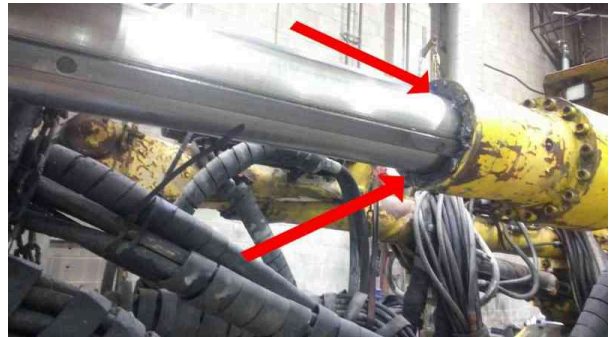
Tefflons of the boom extension very loose, almost 3/8 inch

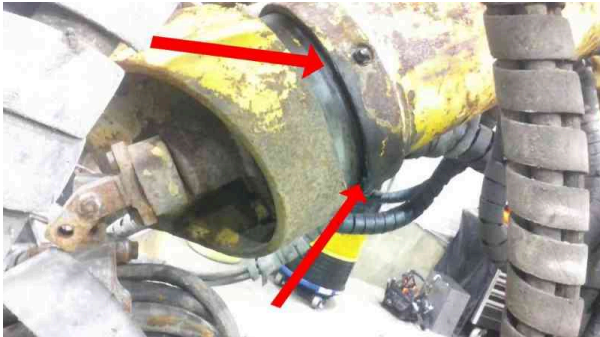
FAIL
Step Title: Check Boom Rotation Unit Condition
Resolution Diagnosis: Very loose more than 1/4 inch, need to be replace
Resolution Action: Replace
Resolution Priority: Critical Safety
Resolution Benefit: Machine Safety
Zone: Left Boom
Subsystem: Positioning System 1
Subequipment: Boom 1 Rotation Units

Very loose more than 1/4 inch, need to be replace

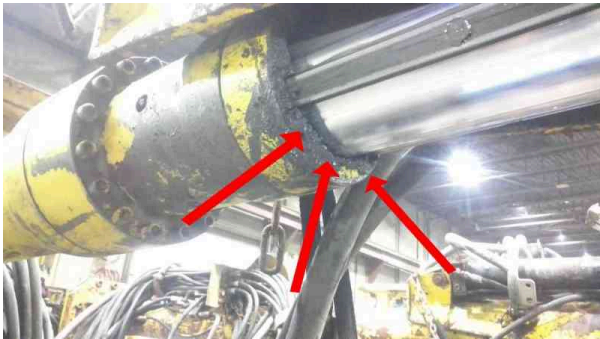
Boom extension cylinder loose in the tefflons and leak internally

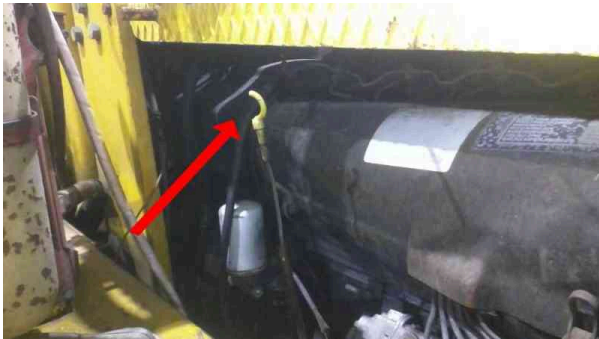
Engine dipstick broken, Engine #F5L912W S/N:8740752

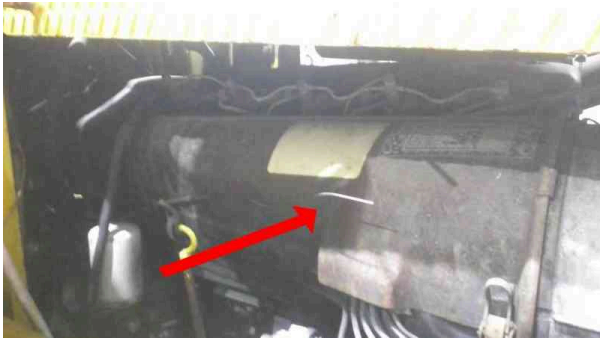
Works only on 600 volts

E-stop not working, shut off cable on the engine broken

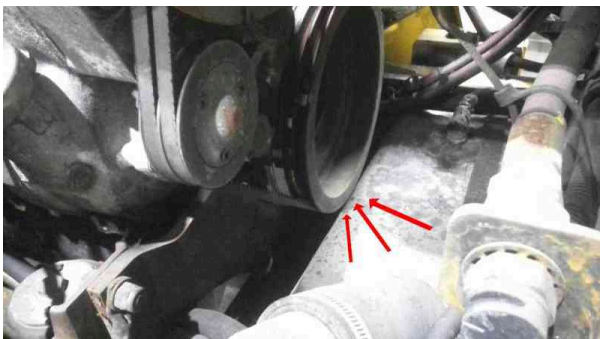
Fuel tank strap is not attach to the brackets and tank is damage by the engine damper pulley

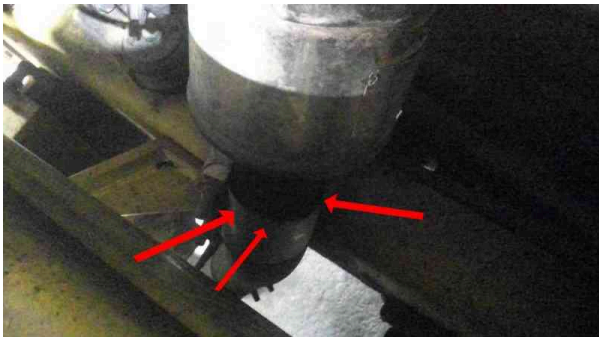
Exhaust clam smoke a lot and need to be replace

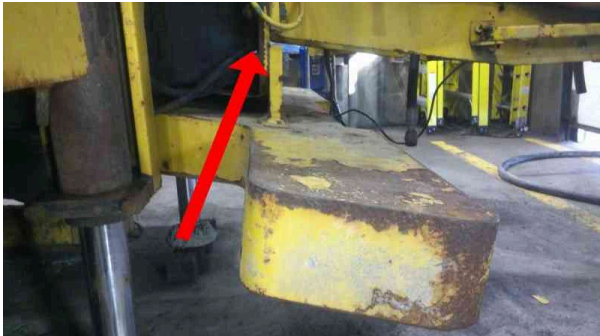
Rear counter weight bracket crowked,need to be repair

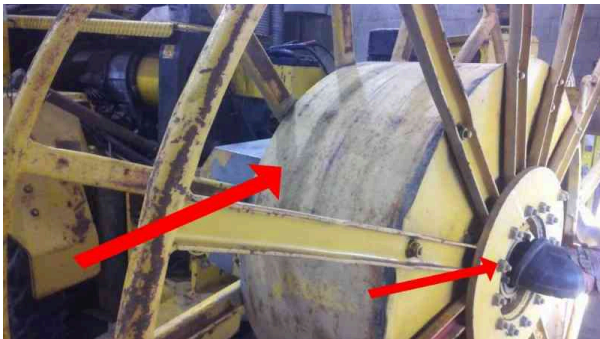
Cable is not secure in the cable reel and cable is missing

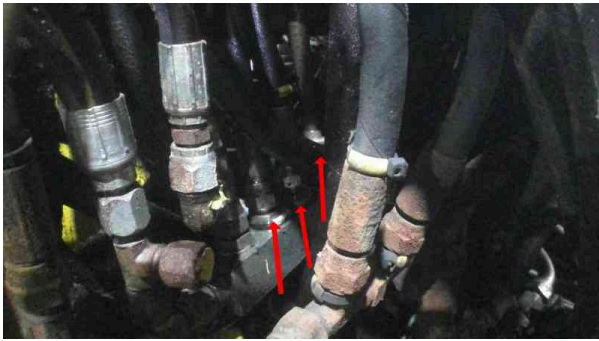
Leak under the operator console

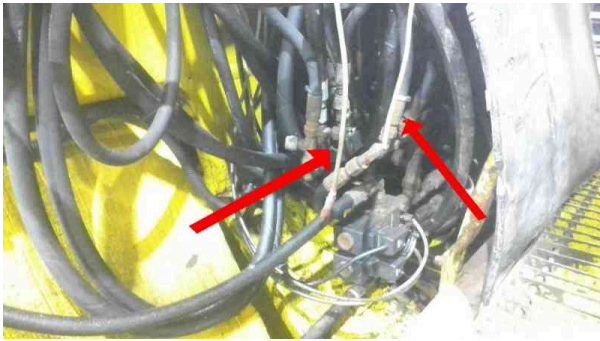
Cut wires under the operator console

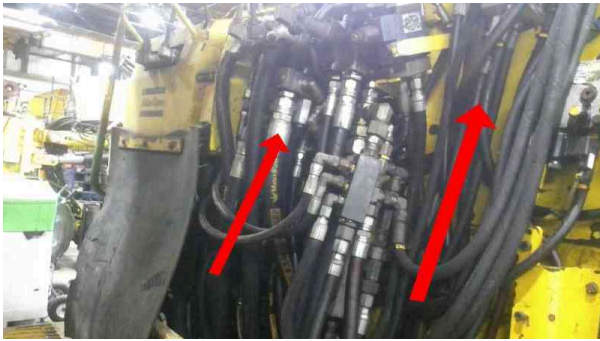
Need to be replace under the operator console

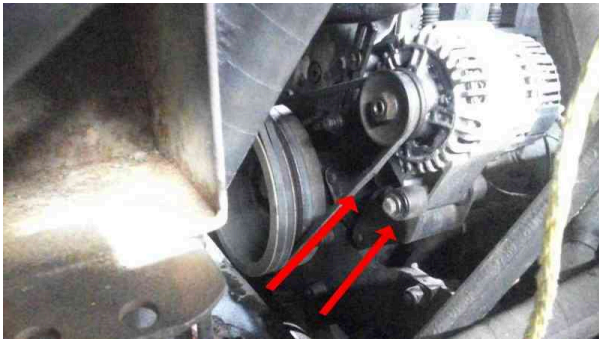
Alternator and alternator belt have to be replace

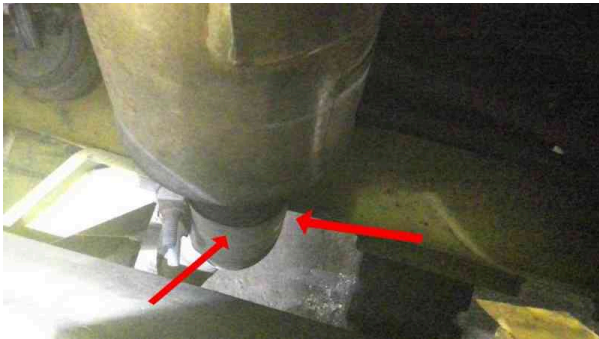
Smoke by the clam

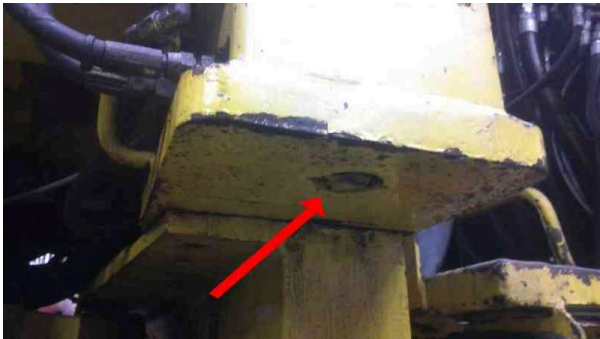
Lifting cylinder right side is leaking

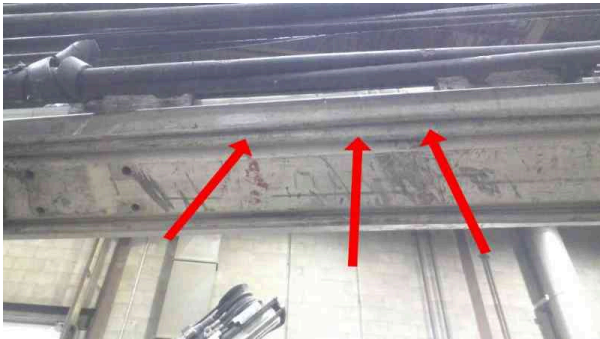
Slide cover take off and dirt underneath

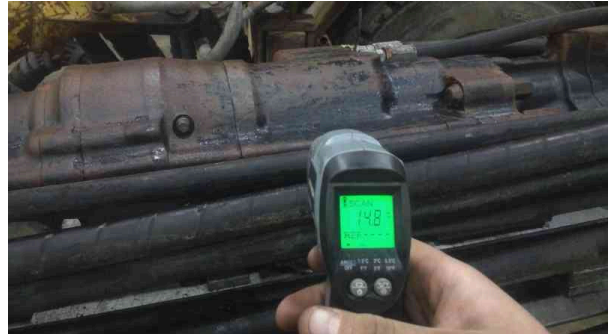
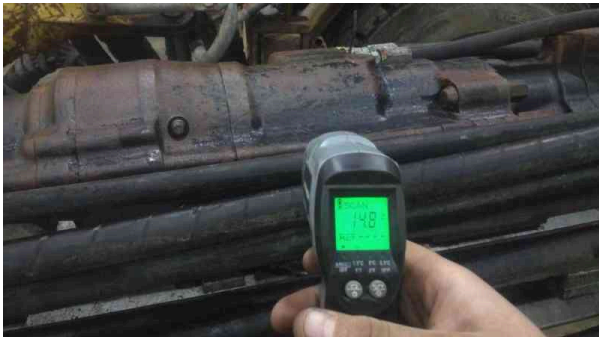
FAIL
Step Title: Check Rock Drill Using Thermal Imaging Camera
Resolution Diagnosis: Drill is not running, have to be rebuilt because the time without work
Resolution Action: Repair
Resolution Priority: Critical Performance
Resolution Benefit: Increased Productivity
Zone: Left Feed and Rock Drill
Subsystem: Drilling system 1
Subequipment: Rock drill 1

Should take the temperature in the field when jumbo is running and drilling, in the shop that's different

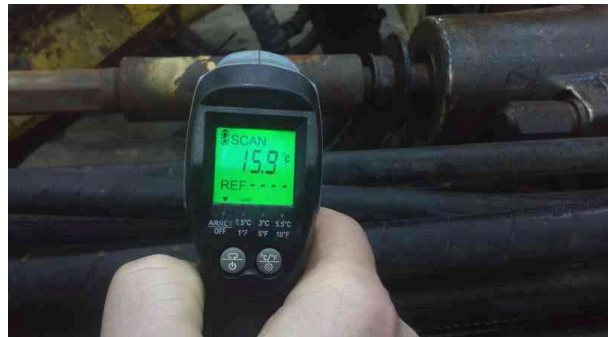
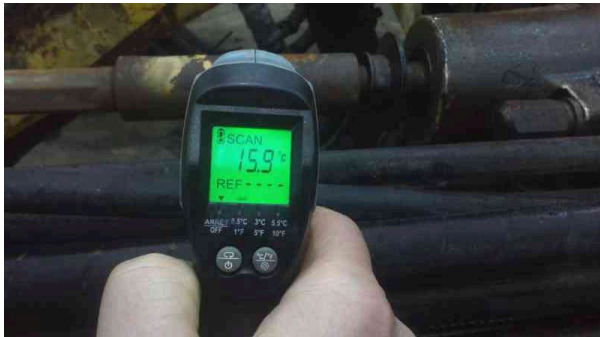
FAIL
Step Title: Check Rock Drill Shank Adapter Using Thermal Imaging Camera
Resolution Diagnosis: Drill have to be rebuilt,not turning because the 600volts issue
Resolution Action: Repair
Resolution Priority: Critical Performance
Resolution Benefit: Increased Productivity
Zone: Left Feed and Rock Drill
Subsystem: Drilling system 1
Subequipment: Rock drill 1

Drill is not running because the 600volt issue,need to be rebuilt

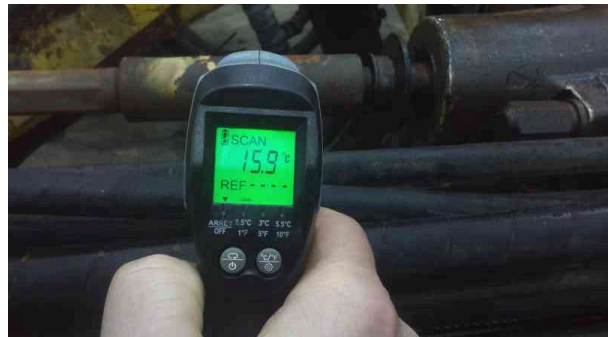
FAIL
Step Title: Check Rock Drill Steel Coupling Using Thermal Imaging Camera
Resolution Diagnosis: Drill have to be rebuilt,not running because the 600volts issue
Resolution Action: Repair
Resolution Priority: Critical Performance
Resolution Benefit: Increased Productivity
Zone: Left Feed and Rock Drill
Subsystem: Drilling system 1
Subequipment: Rock drill 1

600 volts have to be repair first and the Rock drills have to be rebuilt and bench test

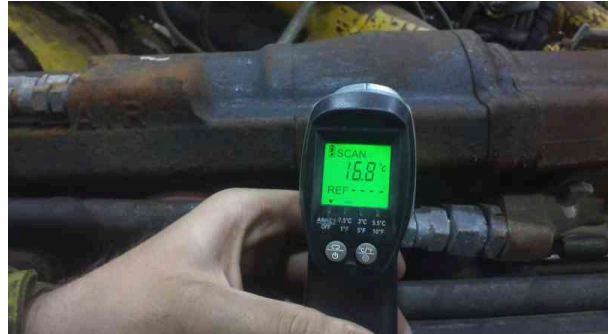
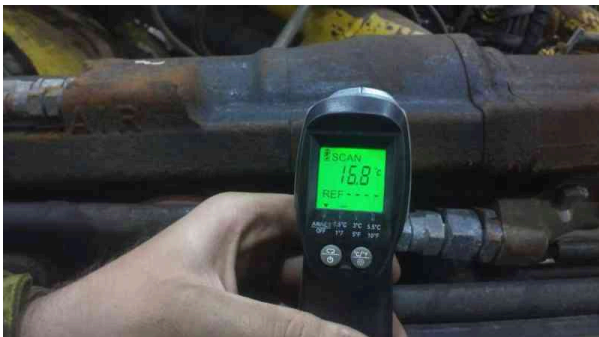
FAIL
Step Title: Check Rock Drill Using Thermal Imaging Camera
Resolution Diagnosis: Drill have to be rebuilt,not running because 600volts issue
Resolution Action: Repair
Resolution Priority: Critical Performance
Resolution Benefit: Increased Productivity
Zone: Right Feed and Rock Drill
Subsystem: Drilling system 2
Subequipment: Rock drill 2

Drill have to be rebuilt,not running because the 600volts issue

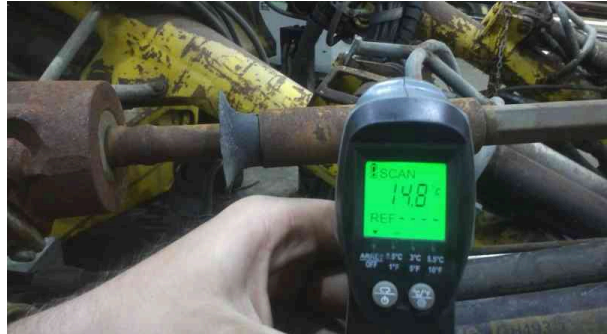
FAIL
Step Title: Check Rock Drill Shank Adapter Using Thermal Imaging Camera
Resolution Diagnosis: Drill need to be rebuilt,not running because the 600volts issue
Resolution Action: Repair
Resolution Priority: Critical Performance
Resolution Benefit: Increased Productivity
Zone: Right Feed and Rock Drill
Subsystem: Drilling system 2
Subequipment: Rock drill 2

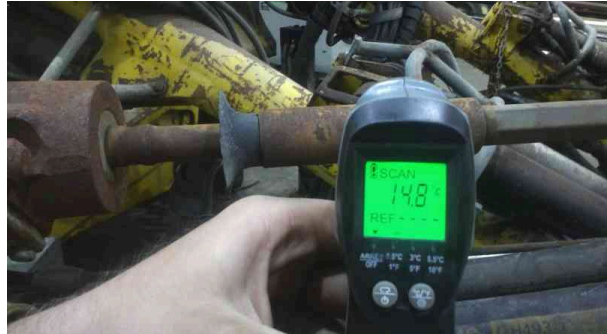
FAIL
Step Title: Check Rock Drill Steel Coupling Using Thermal Imaging Camera
Resolution Diagnosis: Drill have to be rebuilt,not running because the 600volts issue
Resolution Action: Repair
Resolution Priority: Critical Performance
Resolution Benefit: Machine Safety
Zone: Right Feed and Rock Drill
Subsystem: Drilling system 2
Subequipment: Rock drill 2

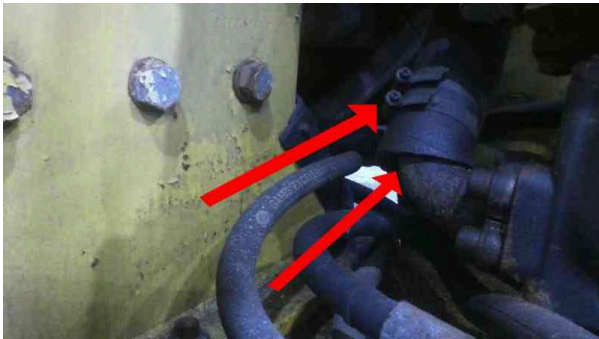
Succion hoses are leakings and need to be replace,wrong clams,wrong hoses

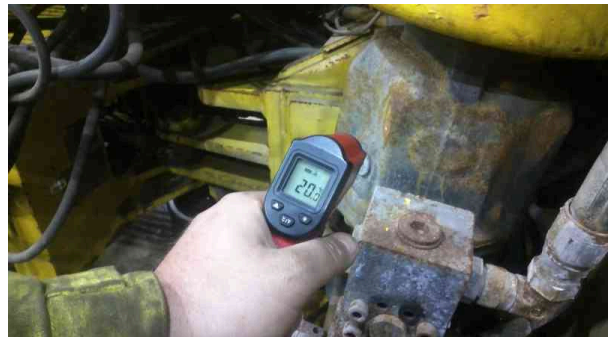
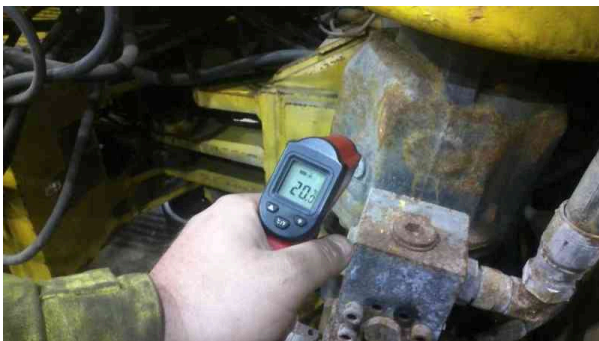
FAIL
Step Title: Check Pumps Using Thermal Imaging Camera
Resolution Diagnosis: Pump is not running because the 600volts issue(wont come on)electric issue in the panel,pump have to be rebuilt
Resolution Action: Replace
Resolution Priority: Critical Performance
Resolution Benefit: Increased Productivity
Zone: Left Rear of Carrier
Subsystem: Hydraulic System 1
Subequipment: Hyd. Pump

Pump not turning because of the 600volts Motor is not starting

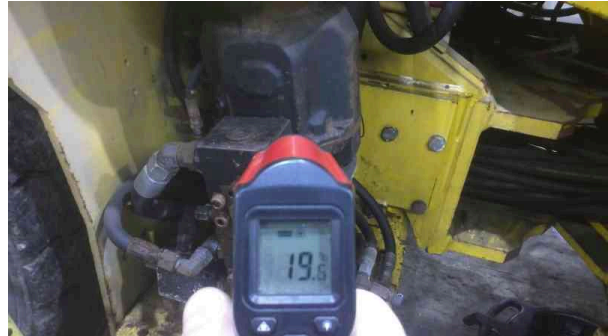
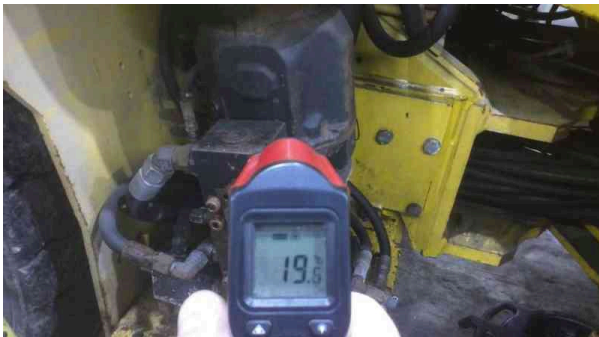
FAIL
Step Title: Check Pumps Using Thermal Imaging Camera
Resolution Diagnosis: Pump is not turning because the 600volts issue,pump have to be rebuilt because the long time without work
Resolution Action: Repair
Resolution Priority: Critical Performance
Resolution Benefit: Machine Safety
Zone: Right Rear of Carrier
Subsystem: Hydraulic System 2
Subequipment: Hyd. Pump

Pump not turning because the 600volts issue,pump have to be rebuilt because the long time without work

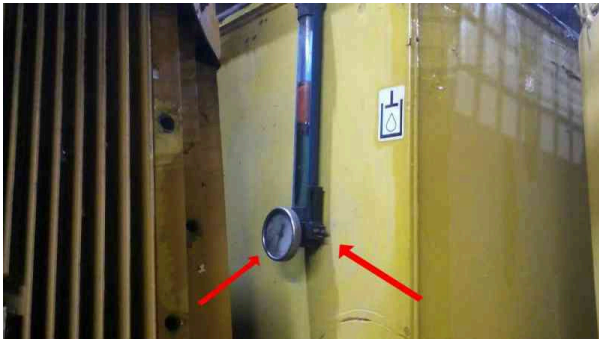
Oil level sensor and temperature gauge not working, have to be replaced

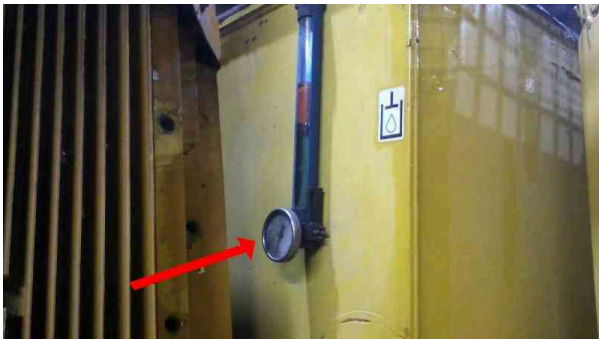
Minimum: 32.00 °F
Maximum: 179.60 °F
Results: -0.00 °F

Gauge not working, have to be replace

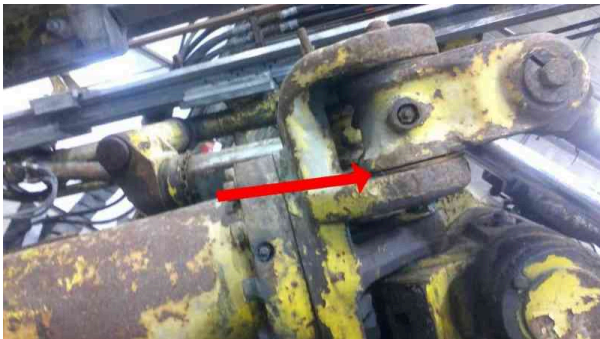
Have to be reshims

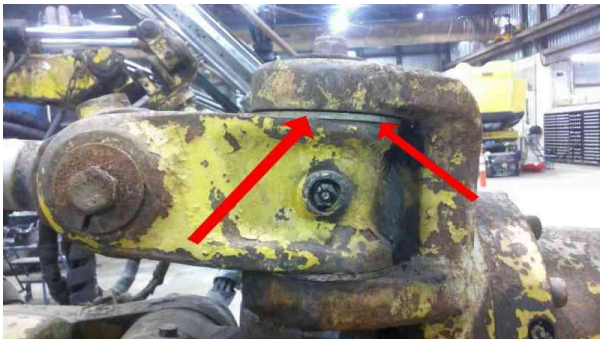
Have to be reshims

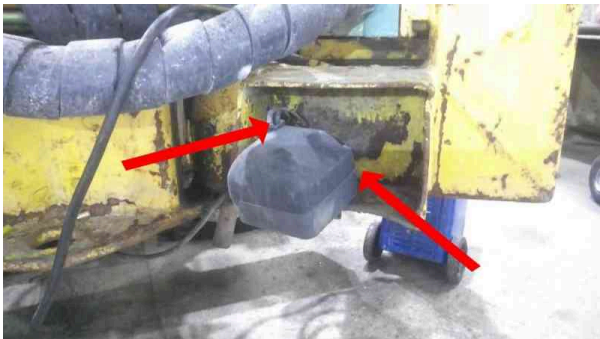
Rear right light broken

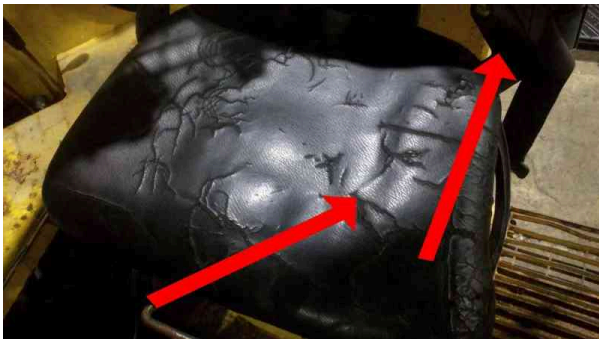
Have to be replace
