## Used machinery exposé

## Furukawa HCR1600 ED

Stand 05/2026

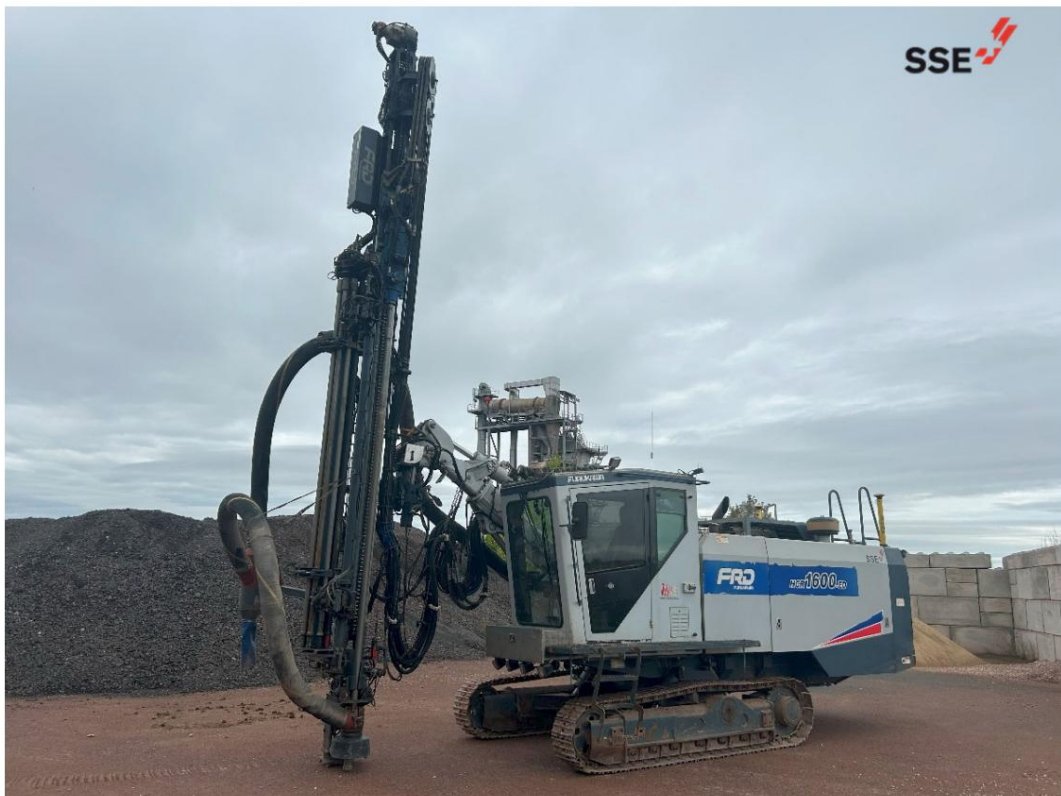
The drilling rig is in good, well-maintained used condition and ready for use.  
The machine has no error messages.  
The drilling rig is dry.

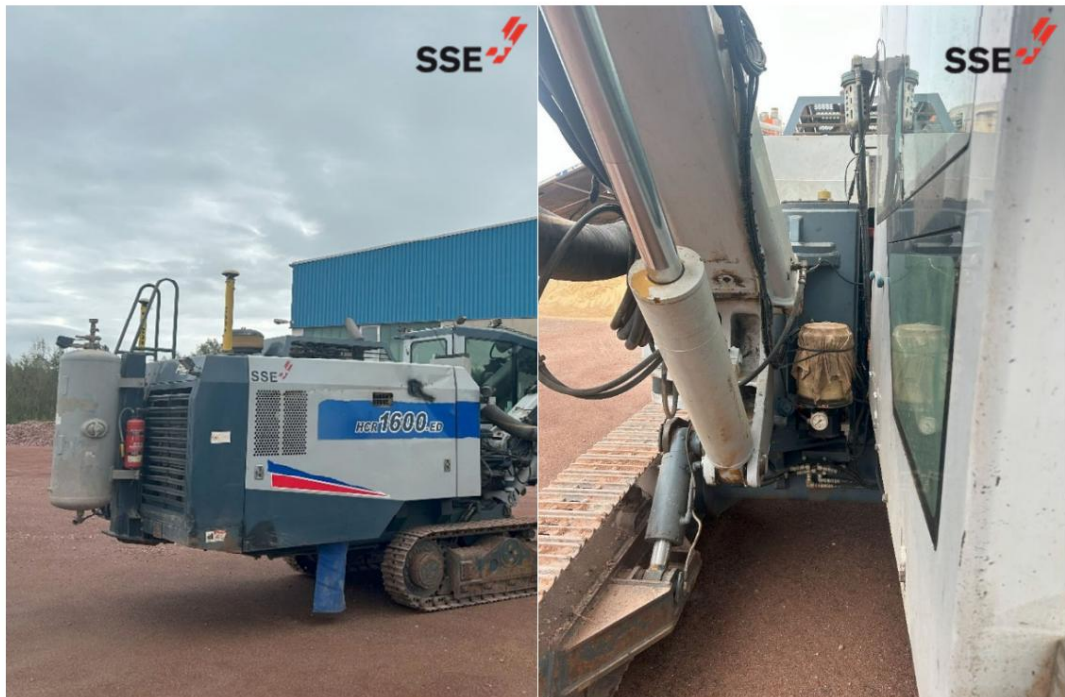
Right side flap: Damage in the upper area (see image on the left)  
Central lubrication reservoir lid defective (see picture on the right)
